## 4-Point Inspection

**Address Inspected** 1234 Acme Rd.

**Date Inspected** 6/14/2017

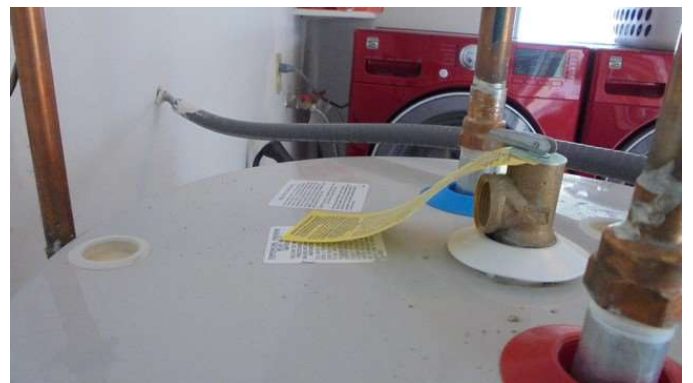
- ☐ Active Leak
- ☐ Prior Leaks
- ☐ Connection / Hose Conditions
- ☒ Water Heater TPR valve is not plumbed
- ☐ Other:

TPR valve is not plumbed
