| Doc #: | 1234 |
| Inspector: | Bobby Quigley |
| Date: | 01/01/2017 |
| Dwelling Address: | 1234 Acme Rd. |

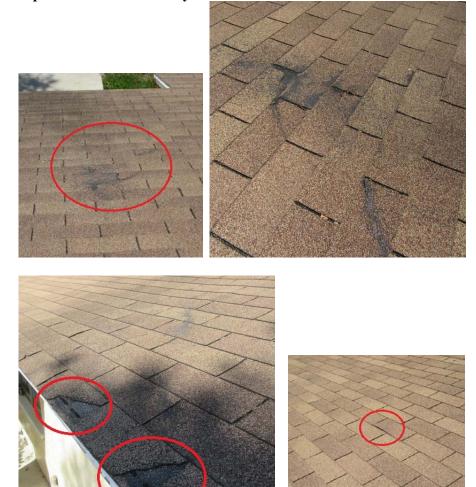
1205. Conditions

Review: Roof shows normal wear for its age and type. Worn, and damaged shingles observed. Popping nails observed. Nails should be secured as part of a

routine maintenance effort to prevent roof damage. These areas need to be corrected for insurance. Recommend review by a licensed roofer for repair or replacement as necessary.

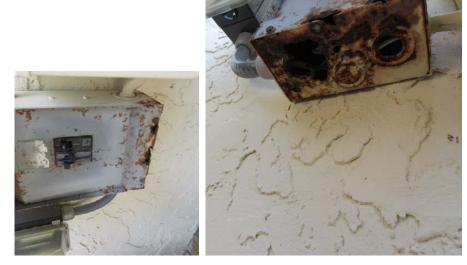
1704. Sub-Panel Comments & Location Review: The sub-panel(s) is in/at pool equipment. Rust/corrosion noted; we recommend that this panel be reviewed and replaced. This should be considered an insurance concern.
